Service Bulletin

Bulletin No.: 16-NA-193

Subject: Dead Battery, Shift into Park Message, Loss of Propulsion, No Start, Multiple DTCs

Brand:	Model:	Model Year:		VIN:		Engine:	Transmission:
		from	to	from	to		
Chevrolet	Volt	2016	2017			All	All

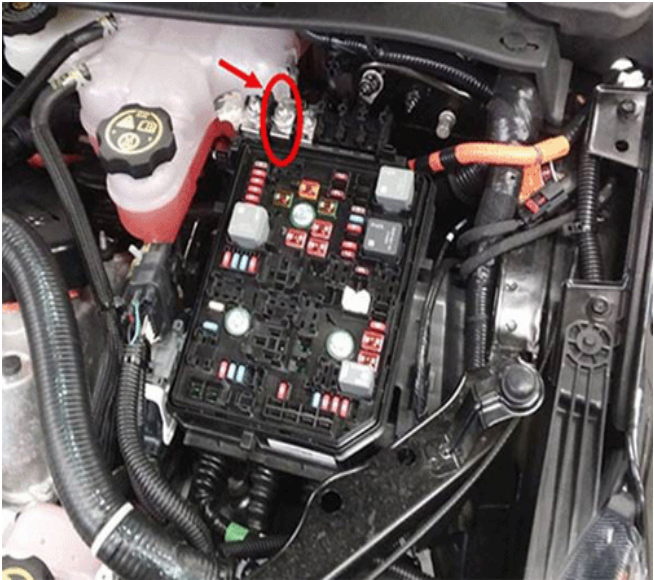
4533040

This may be caused by a loose or improperly installed battery cable for circuit #40 at the X50B auxiliary fuse box right above the underhood electrical center.

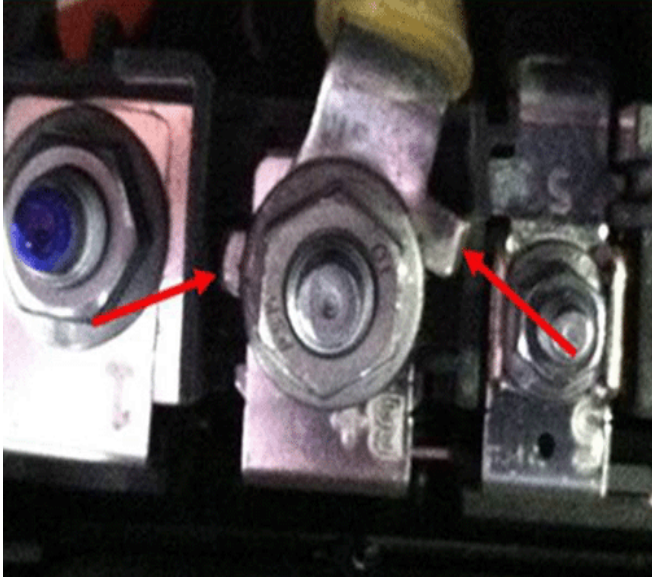
4533041

2. Check the terminal and make sure that the terminal is straight and the tabs are properly in the fuse box. Above is a picture of a terminal that was improperly installed.

Note: The tabs of the terminal are stuck on a plastic boss of the fuse block which causes the nut to be tight but the terminal is not flush in the fuse box, which causes a poor connection with the bus bar in the fuse box.

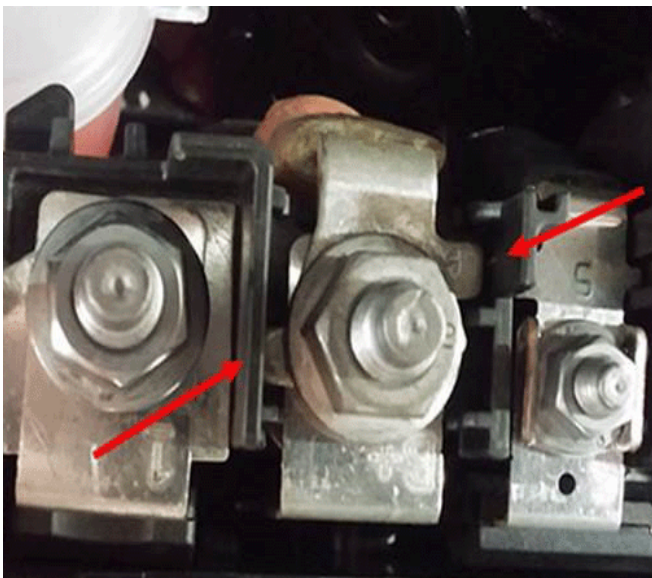
4533043

Note: See photo above of a properly installed terminal. Notice that the terminal tabs are located in the proper recess of the fuse box.

3. If the connection above is properly seated and torqued (torque requirement 15 Nm or 133 in/lb) on the vehicle as pictured in the photo above, check all the connections at the X50D fuse box that is located on the side of the 12V battery.
